# **Instruction Manual**

## **Service Software**

### **testo 270\_v2014**

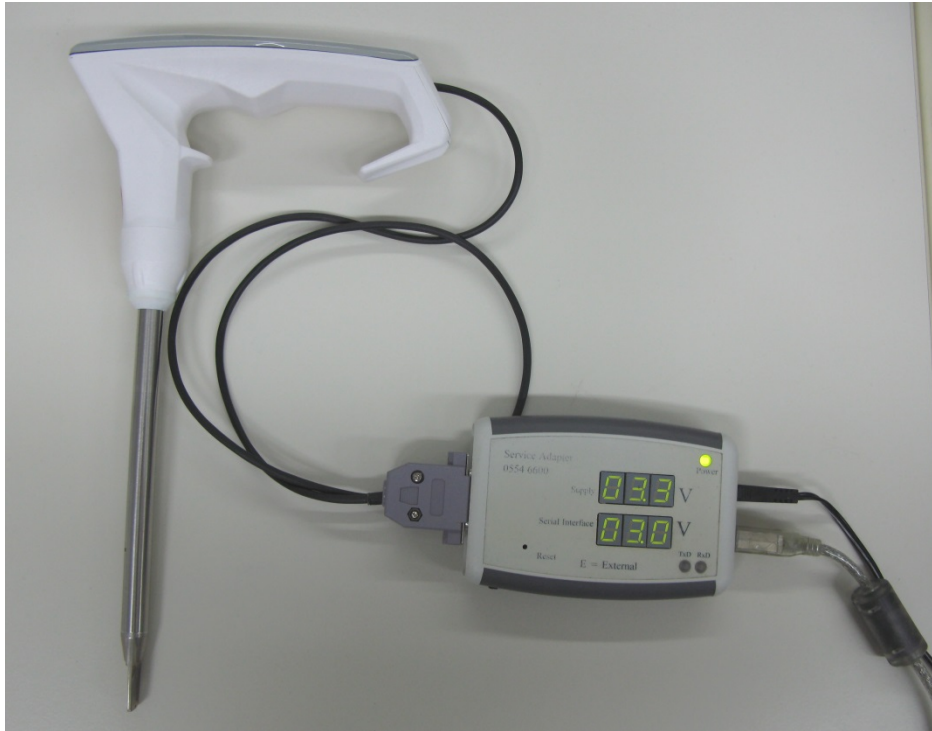
The communication between the testo 270\_v2014 and the PC is done via the Universal Service-Adapter 0554 6600 and the new service-adaptor cable 0449 2750.

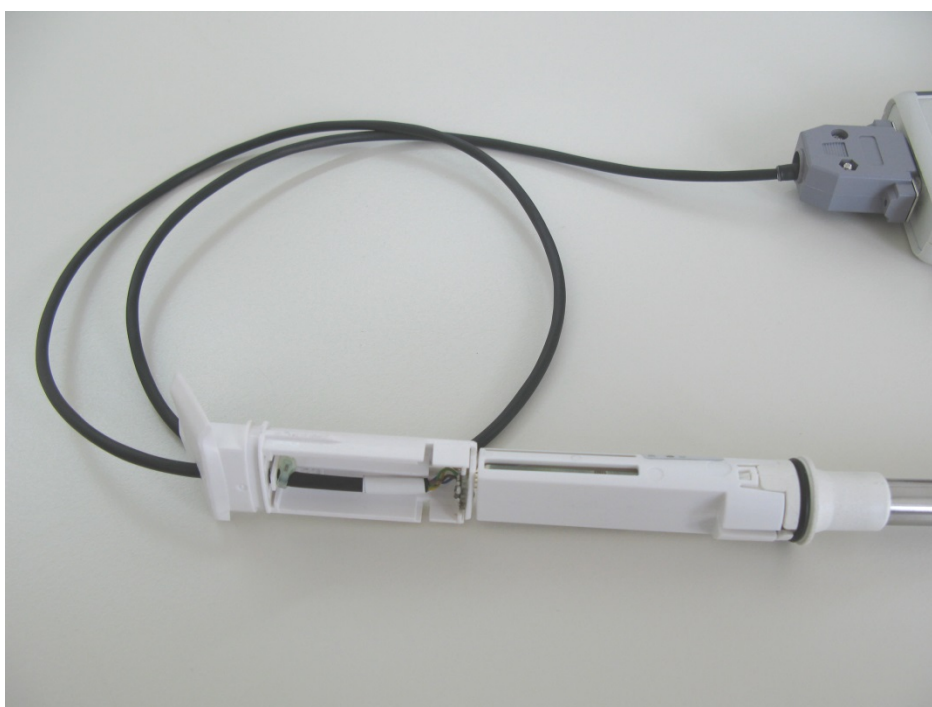
In order to do a firmware update of the probe it is required to connect the service adapter cable 0449 2750 directly at the probe socket as shown on the photograph.

**ATTENTION:** before starting a **Probe-Update** „Flash Sensor“ the probe must be separated from the display unit and must be connected via adapter cable 0449 2750 to the Universal Service adapter (See: Communication).

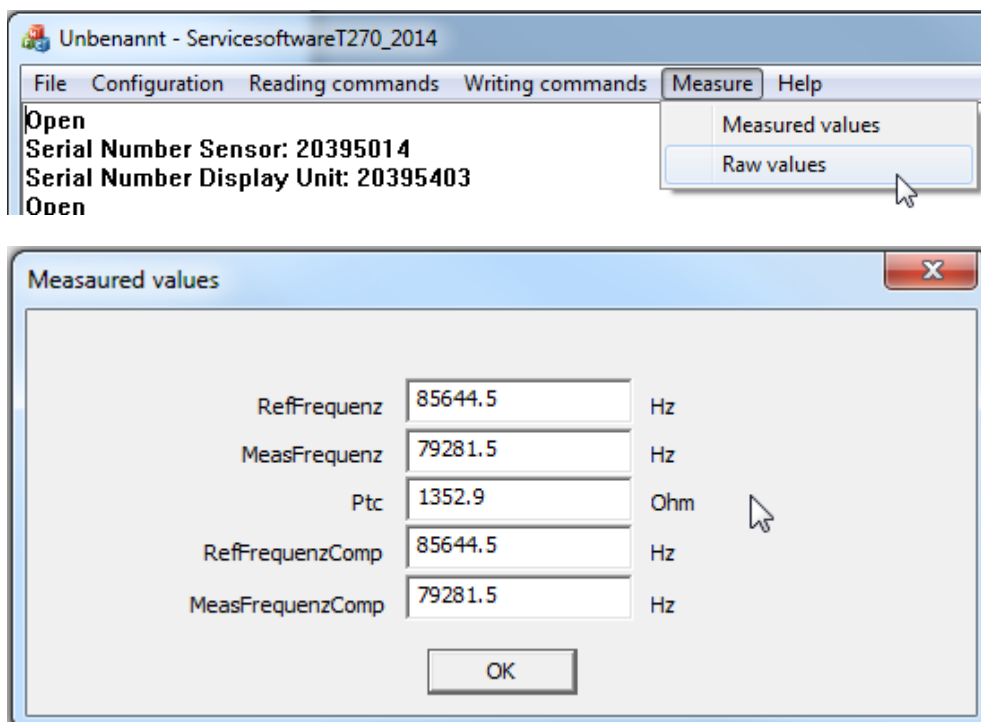
The online measurement of the sensor channel values is done in a 1 sec. measuring cycle.
